Experiences from Transformer Onsite Refurbishment

Presented by Robert Li (Substations Maintenance Manager, TransGrid)
Australian A2, Melbourne – 20 May 2021

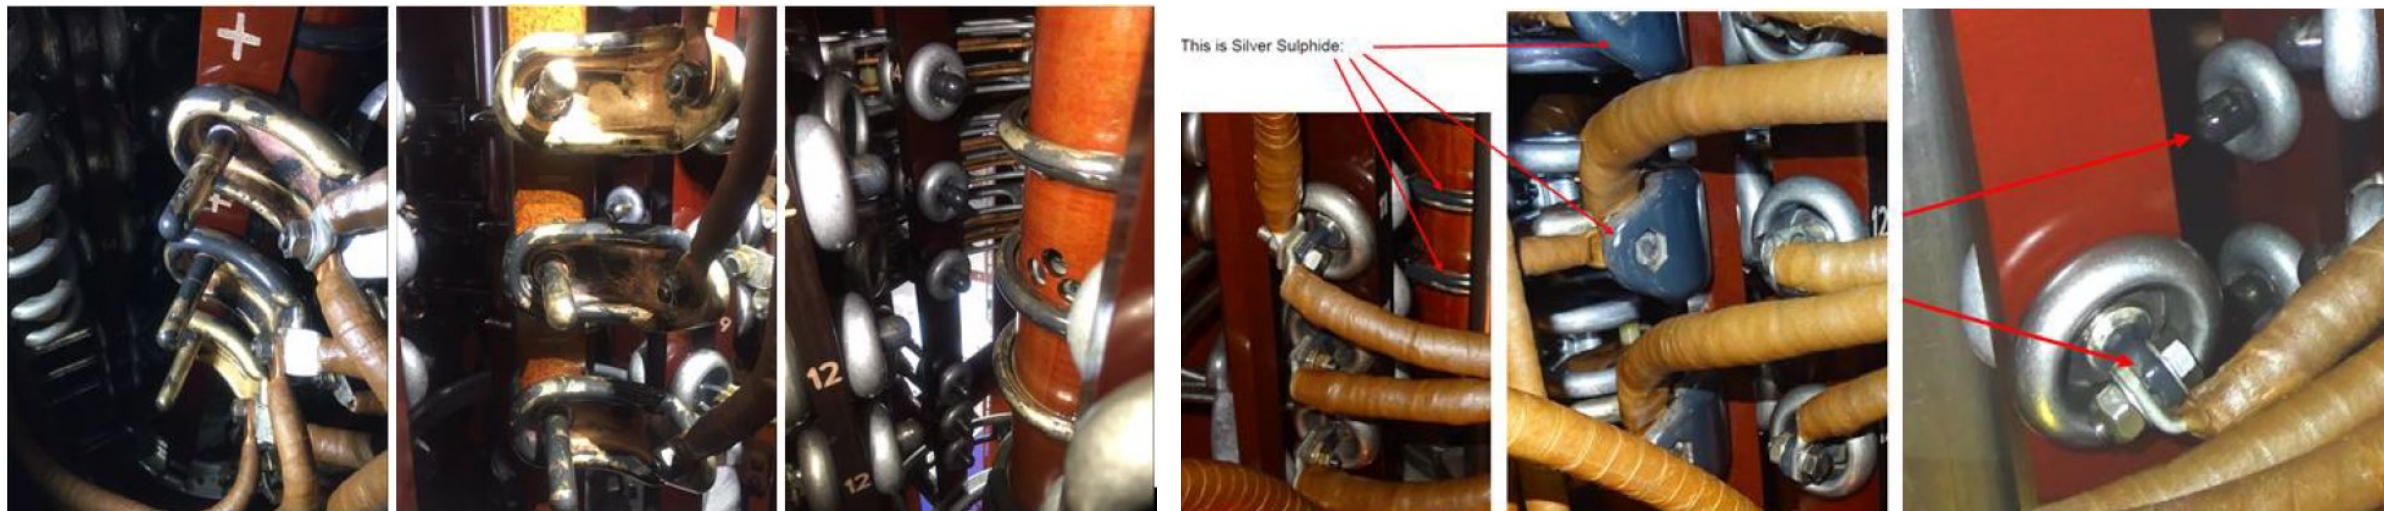
Silver Sulphide Deposit on the selector contacts of Transformer H & K

- Various degrees of silver sulphide corrosion were found on selector switch contacts of Transformers S, H, K and G. These transformers' health indicators and available service history prior to refurbishment could not account for this silver sulphide corrosion.

- The past Fuller's earth oil treatment starting from late 1980s to early 1990s is highly likely to be the contributing factor. Two units failed due to silver built on infrequently operated K switch.

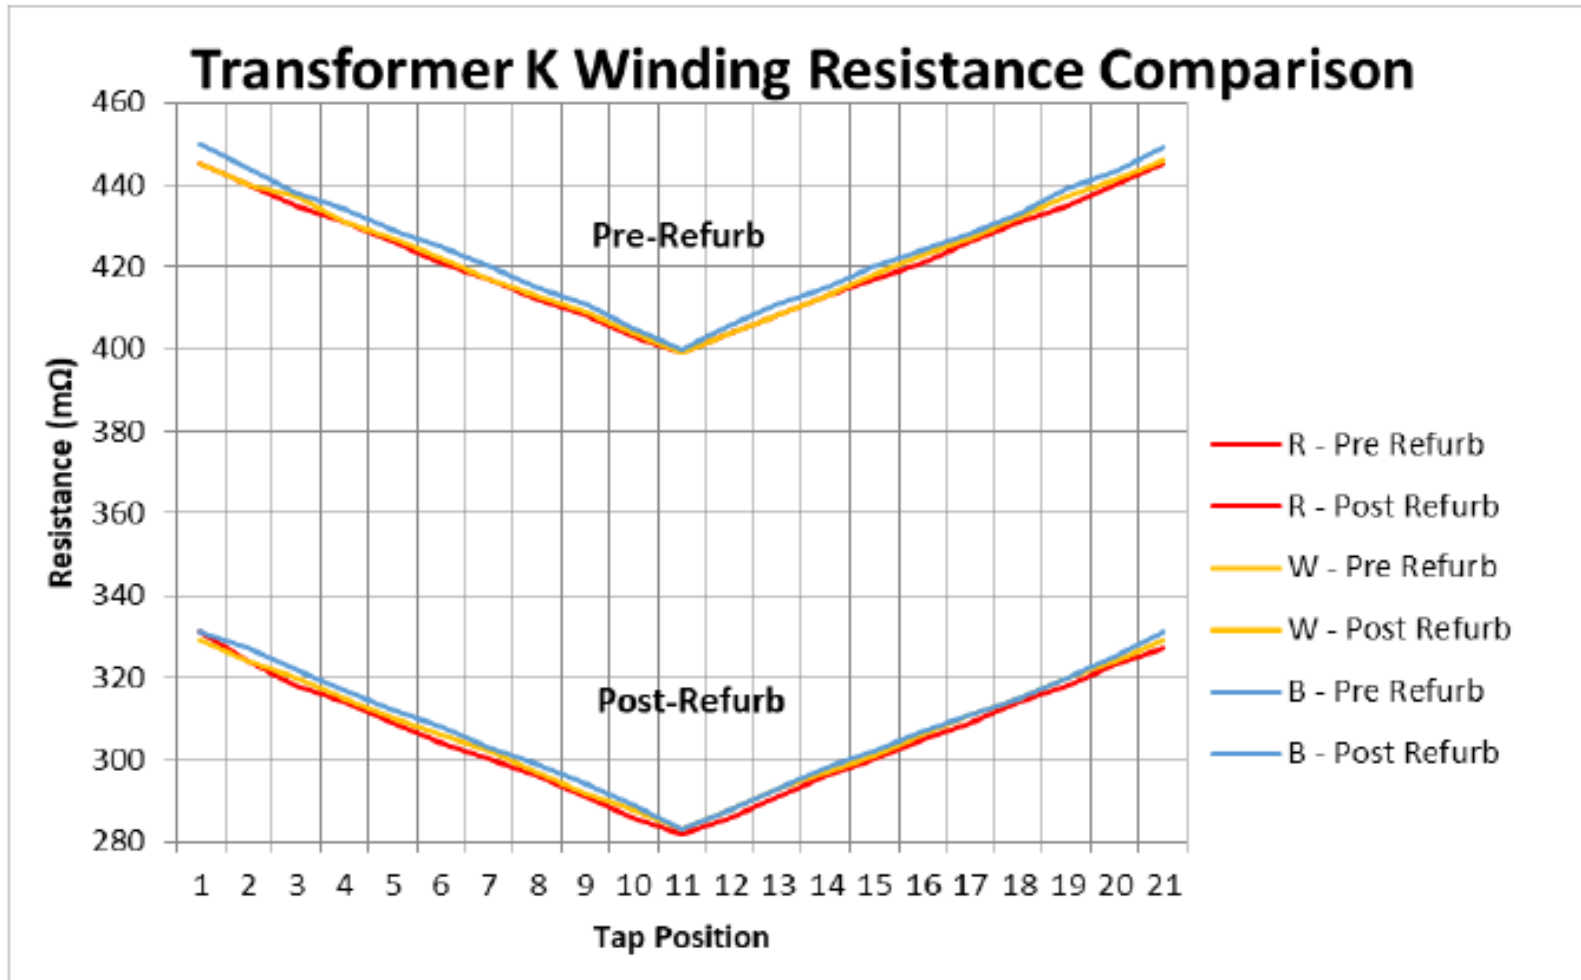
Transformer K's Winding Resistances Comparison through tap range before and after refurbishment

Silver Sulphide Corrosion on Selector Switch

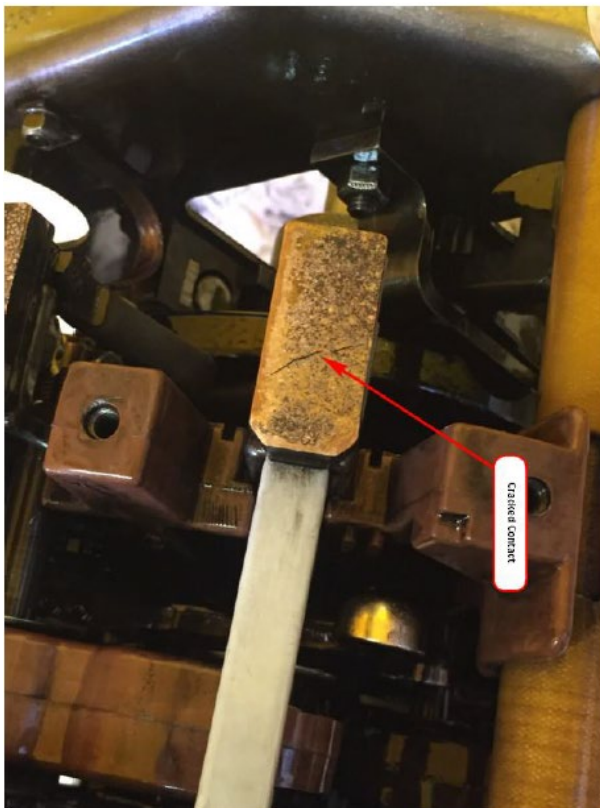
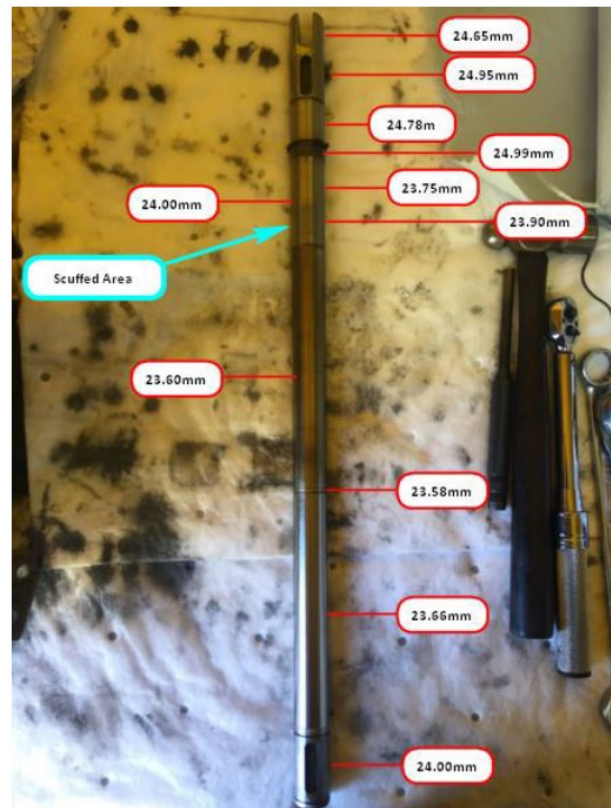
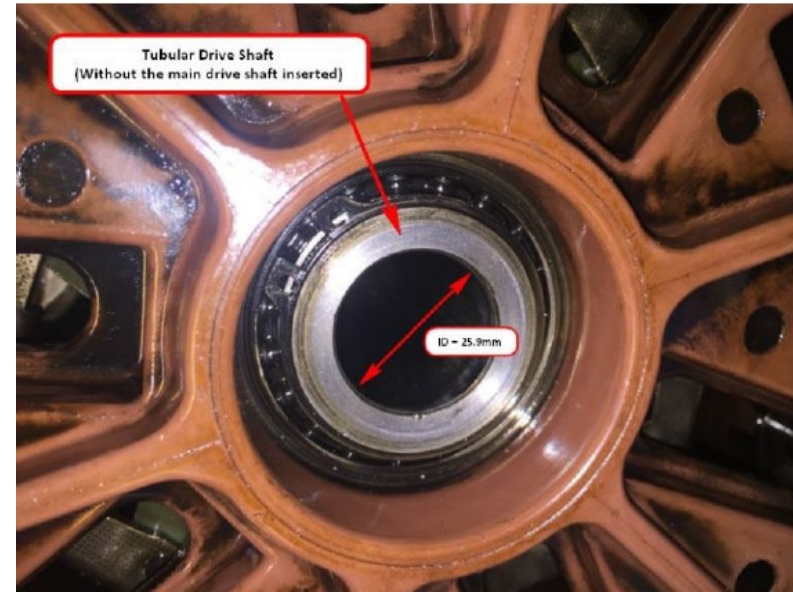
Tap Changer Drive Shaft Wear

Tap changer specialist was engaged to inspect the diverter switches of Transformer F (330kV, 375MVA, 1982). This Tx's tap changer has more than 350,000 operations, one of the highest among the fleet.

Inspection found both drive shaft and inner sleeve on guide plate had significant wear on all three phases. Shunt contacts on two phases did not meet OEM's tolerance.

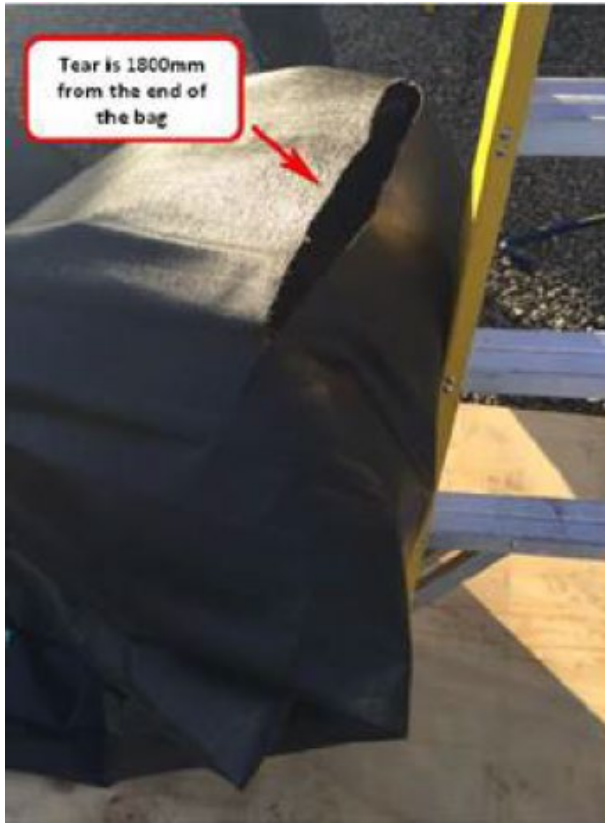
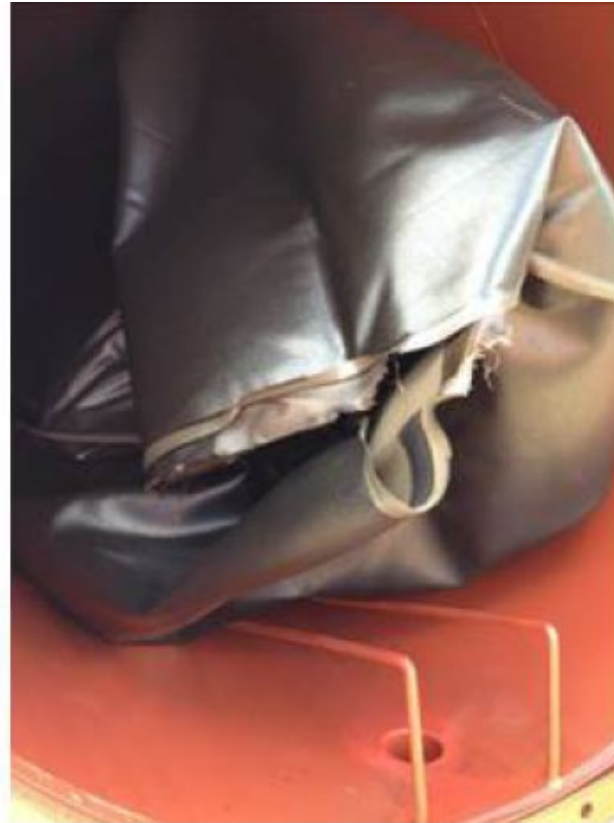
Ruptured Conservator Bag

- Conservator bag on a number of transformers were found ruptured – due to inappropriate maintenance or installation

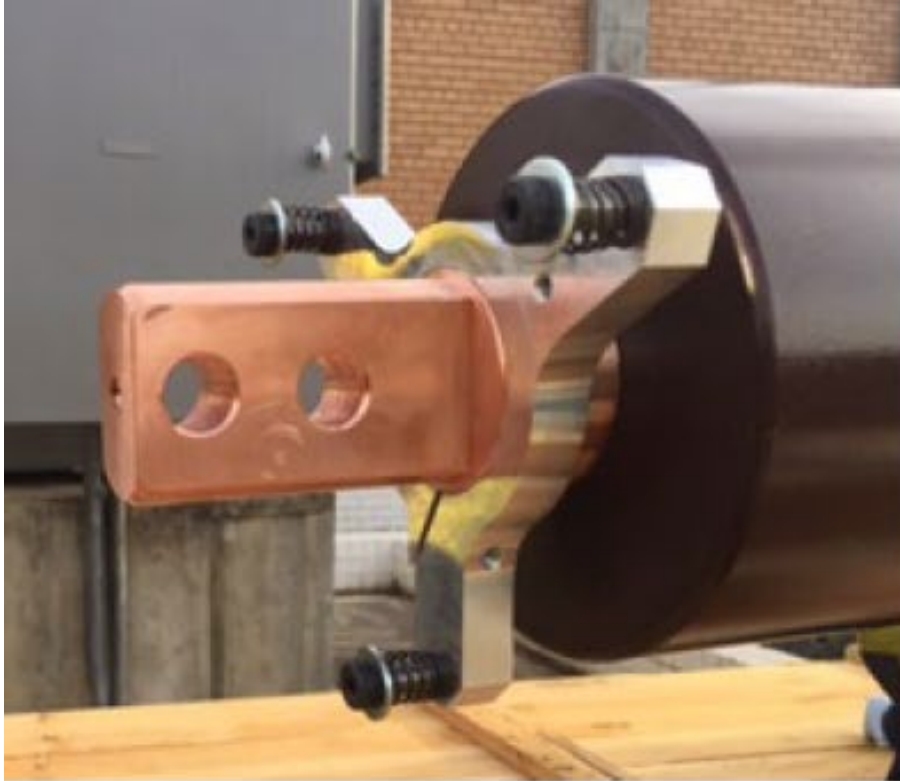
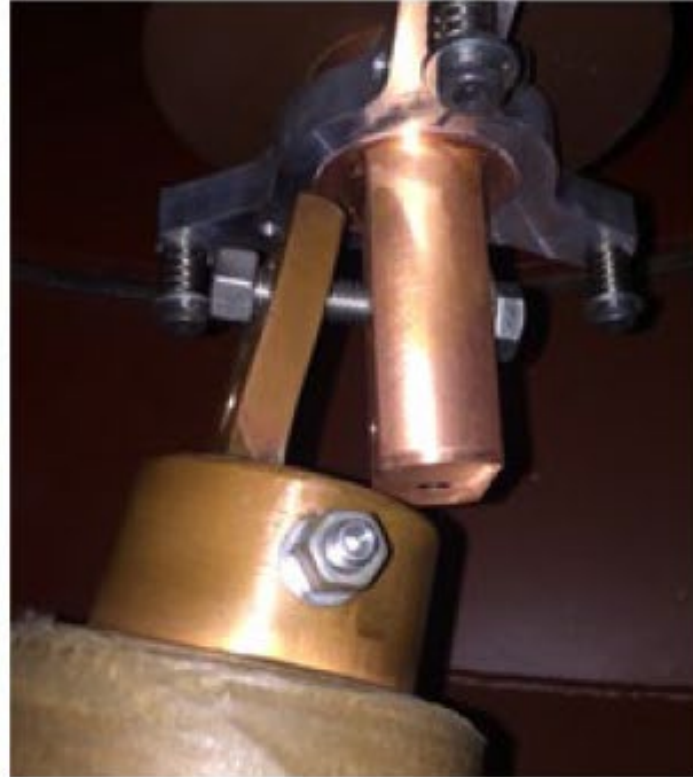
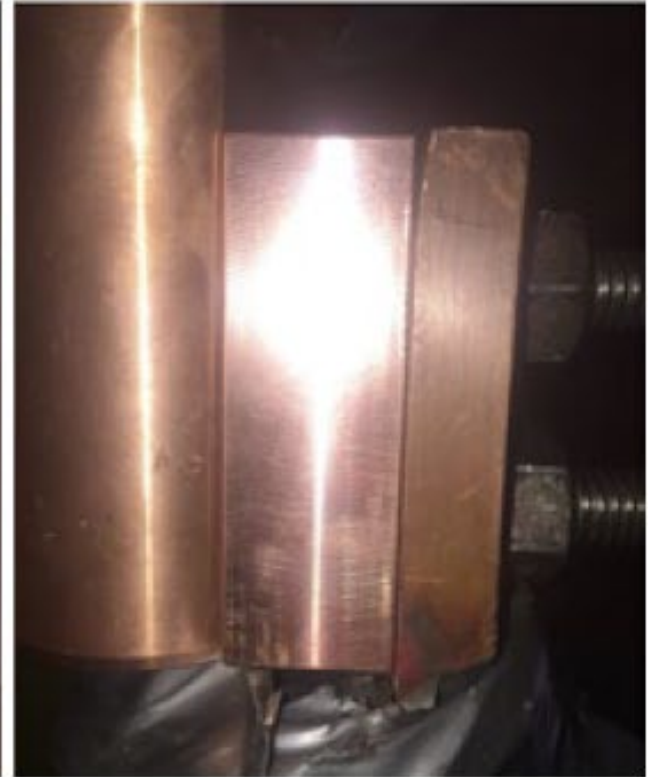
Issues with Bushing Replacements

Solutions to fit the winding connection of new RIP bushings

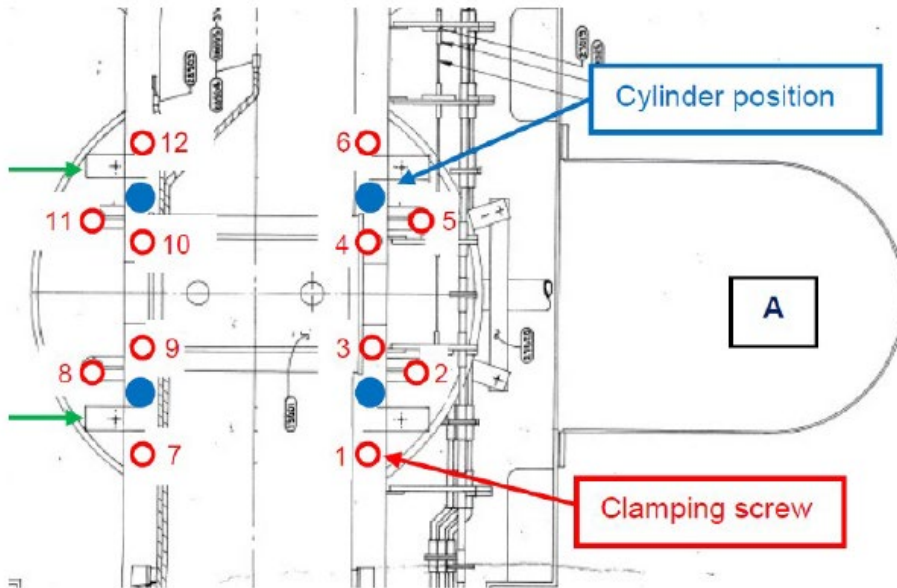
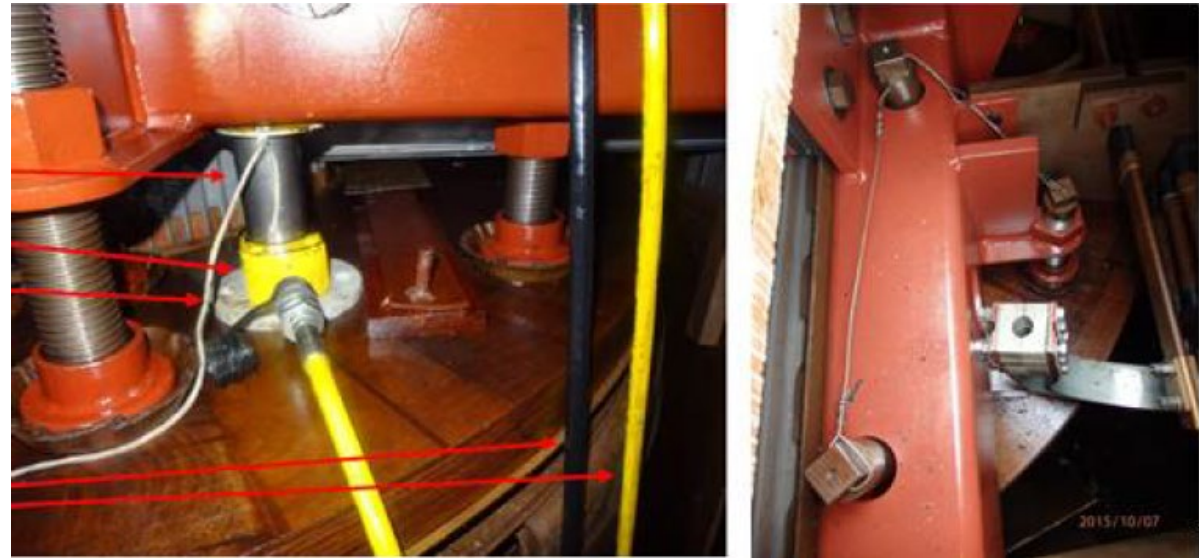
- Winding clamping pressures were checked only on three transformers, G, J and K by contracted specialists
- The TSO's upper limit for applying re-clamp pressure is 65% of the factory value (85 tonnes per phase): 55 tonnes - mitigates the danger of over-clamping that winding.
- With non-uniform relaxation of the insulation structure after 30 years, it is possible that one winding is taking a greater proportion of the total force.

- Residual clamping forces of each phase of Transformer G, J, K in tonnes (% of factory original value)

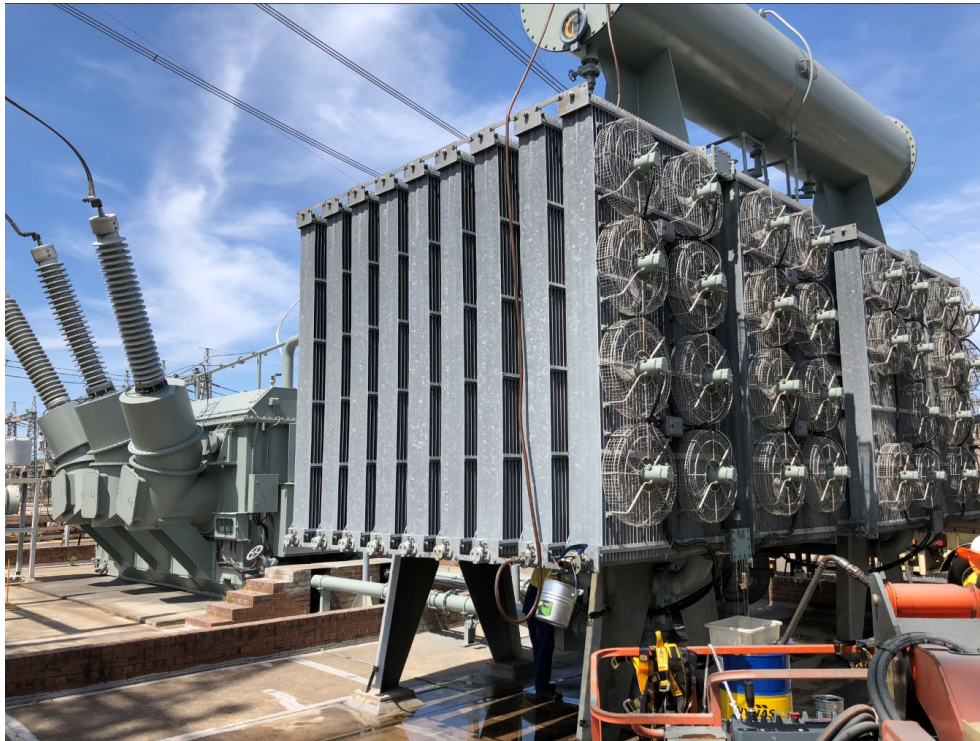
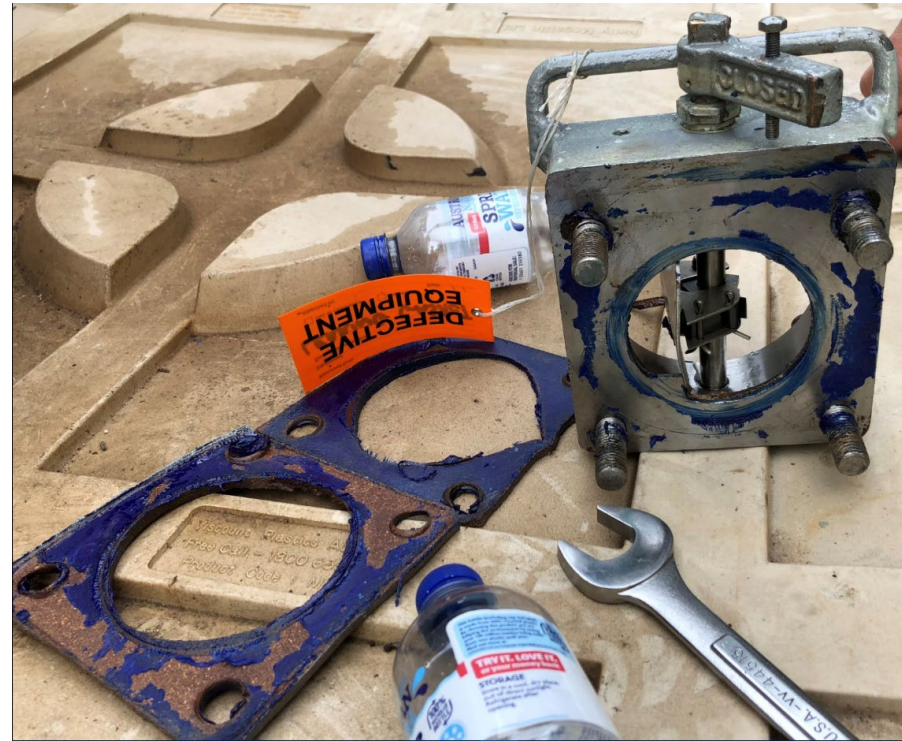
New leak & Re-Emerged leak

- Transformer L's cooler bank gate valve leaks 9 months after refurbishment due to defective new gasket fitted
- Leak re-emerged from Transformer T's diverter lid 13 months after refurbishment due to insufficient bolts tightening

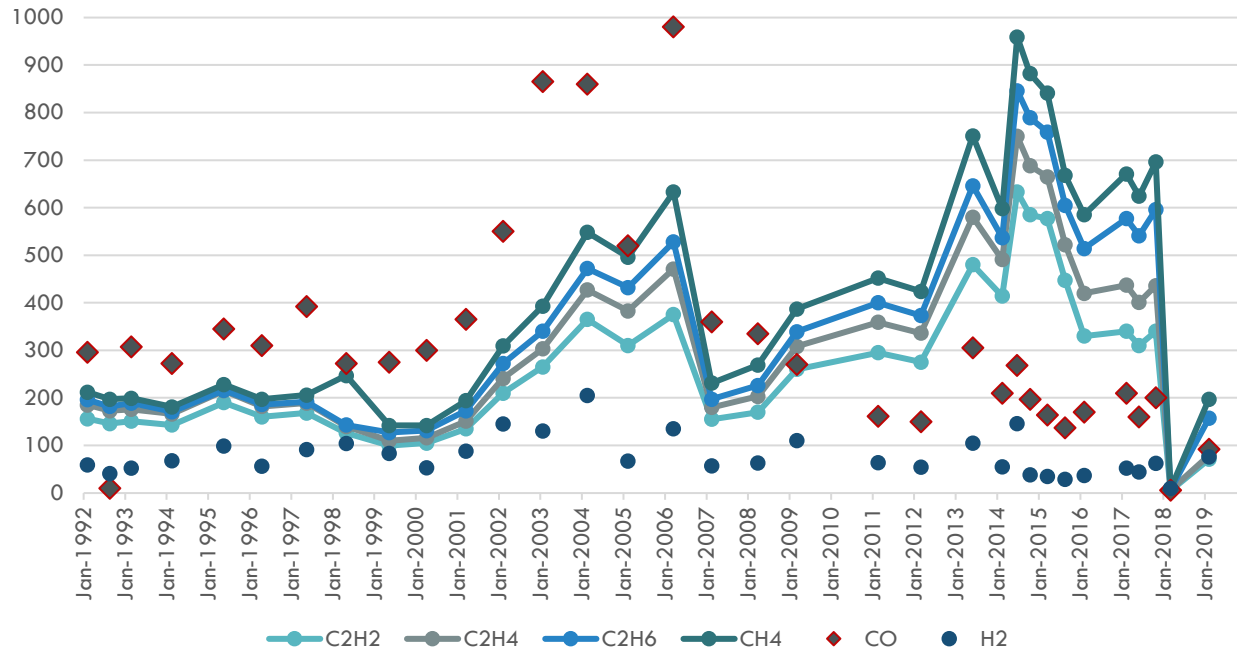
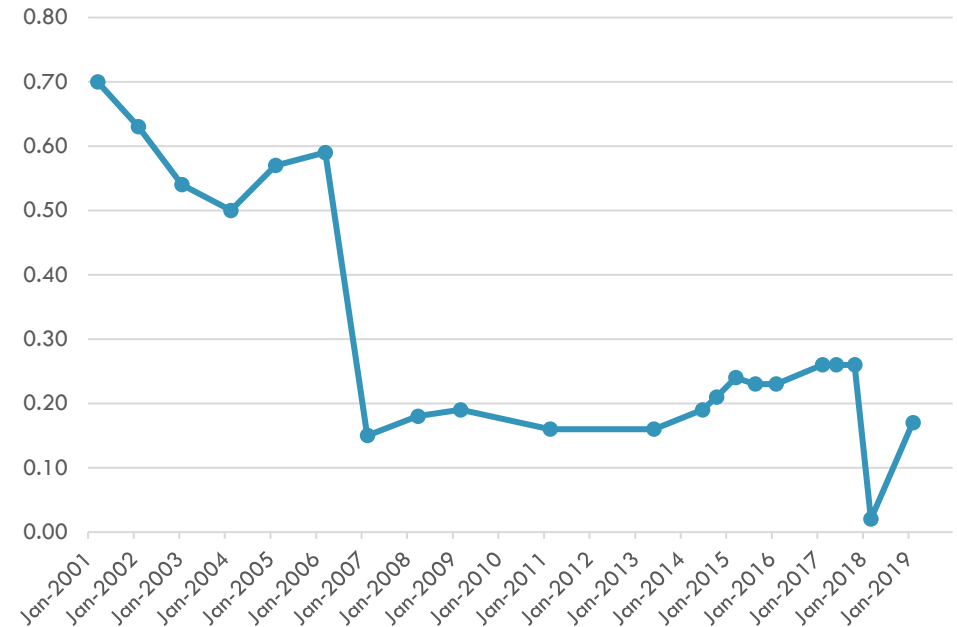
Key health indicators comparison – Transformer T & S (15MVA, 132/22kV, YOM 1968)

- Two sister units in the same substations. Refurbished in Dec 17, the oldest of the group. DP: 603~697 (lowest among this group). Oil replacement in May 2006.
- No conservator bag. External nitrogen bag fitted in 2000 however its performance is questionable.
- Silver sulphide corrosion was found on the selector contacts of Transformer S only.
- Since refurb, furans have been slowly migrating from paper back into oil.

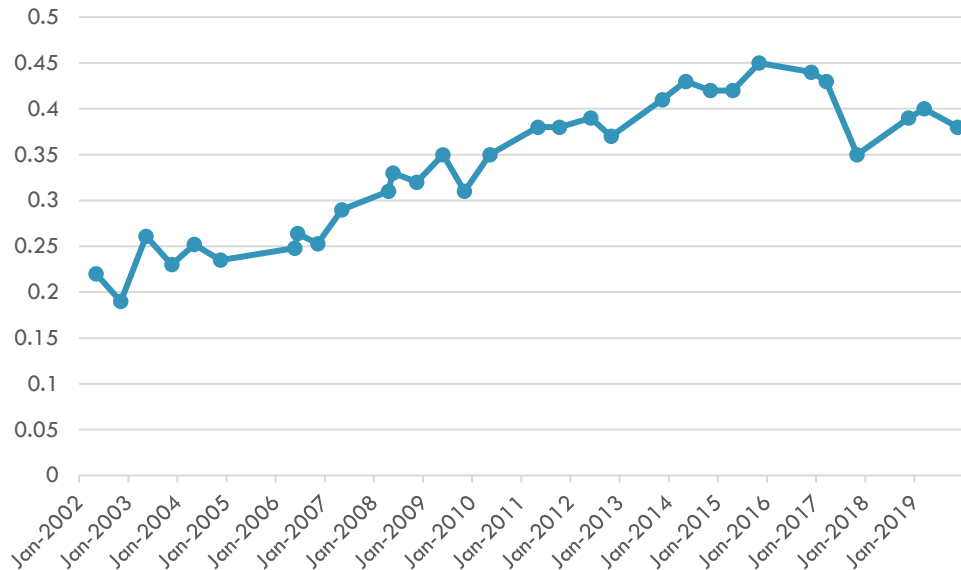
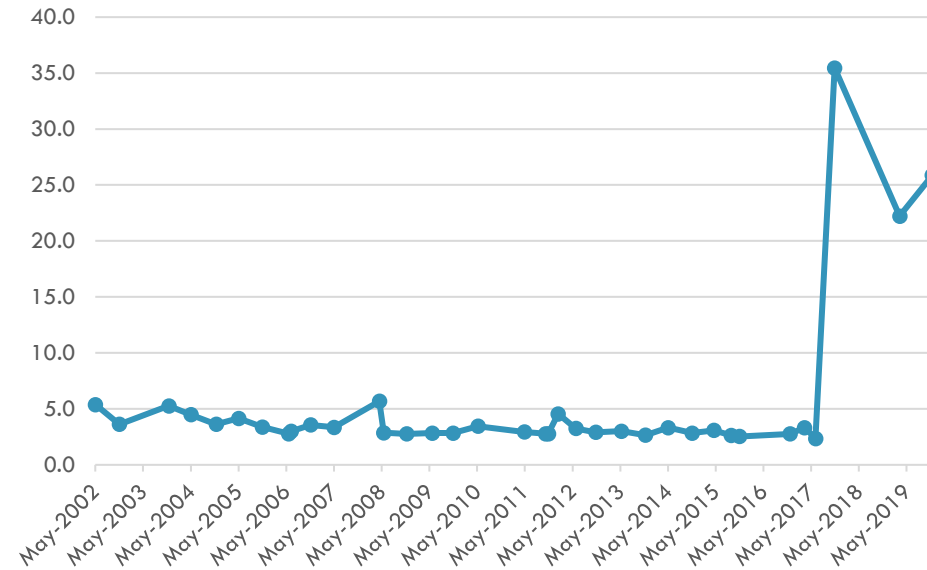
Key health indicators comparison – Transformer I (375MVA, 330/132kV, YOM:1981)

- Refurb completed in June 2017. This unit shares the same design as Transformer L, K, H, J, F, G, I and E from late 1970s to 1980s.
- Paper DP ranges between 711 to 880. Furans have been increasing from 0.2 to 0.45 ug/g in the last 14 years (highest Furan among this group). Furan has come back but stabilised post refurbishment
- Conservator bag found defective and replaced during refurbishment. Effect of bag replacement on N2/O2 ratio in oil is shown below
- It has been suffering from severe chronic leak since 1997. Numerous forced outages due to low oil. Attempts to slow the leak have only partially worked. Prior to refurbishment, leak rate per year was 200L.
- Lack of conservator bag and severe leak over the past two decades are considered as the reason behind the high Furan level.
