Power transformers and reactors

Transformer bushing reliability

Reference: 755

February 2019

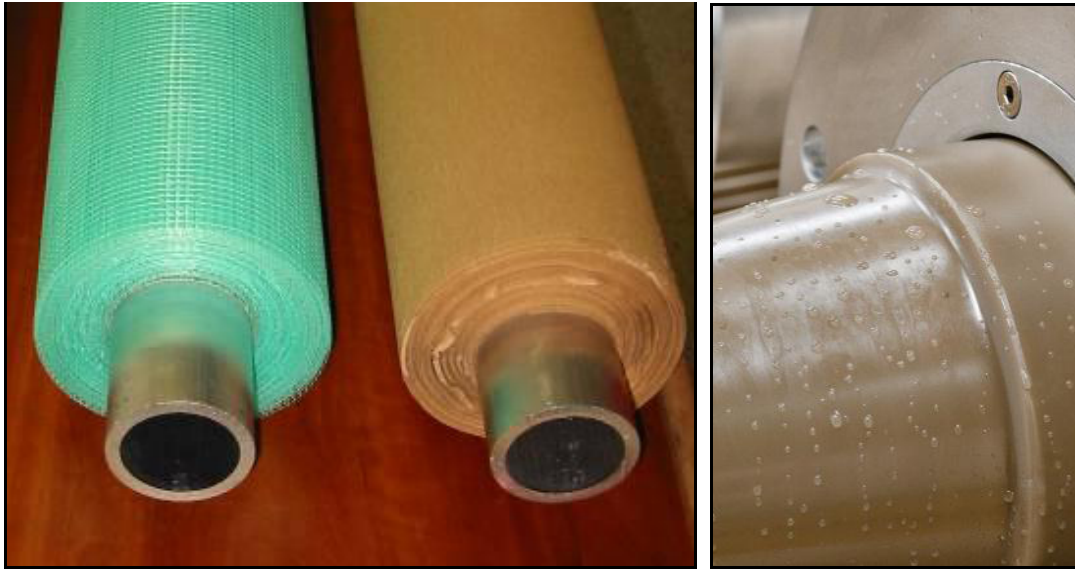
Figure 2.2.1: RIS and OIP bushing unimpregnated condenser body (left), RIS high hydrophobicity (right)

The Resin-Impregnated Synthetics (RIS according to [2.1], but other abbreviations are used too), technologies of dry high-voltage capacitance-graded bushings have been developed in recent years by different manufacturers. RIS transformer bushings are being manufactured today for voltages up to and including 330 kV and service experience is being collected, [2.2.1, 2.2.2]. When compared to OIP and RIP bushings, in RIS technology paper is replaced by synthetic fibre fabric, Figure 2.2.1. The condenser core is wound from this fabric with inserted field-grading foils and the assembly is impregnated with inorganic-filled epoxy resin. After hardening, the outdoor part of the bushings may be directly overcoated with silicone sheds. Most of the differences of RIS with respect to the traditional technologies comes from the elimination of the cellulose from the insulation material and from application of the inorganic particle-filled resin, and because of this humidity absorption is practically eliminated. The lack of paper in the material means there is no need to dry the core prior to impregnation with resin, and very good storage properties, independent of the storage environment. As a result, the dielectric loss factor of the bushing does not depend on the storage conditions [2.2.1].

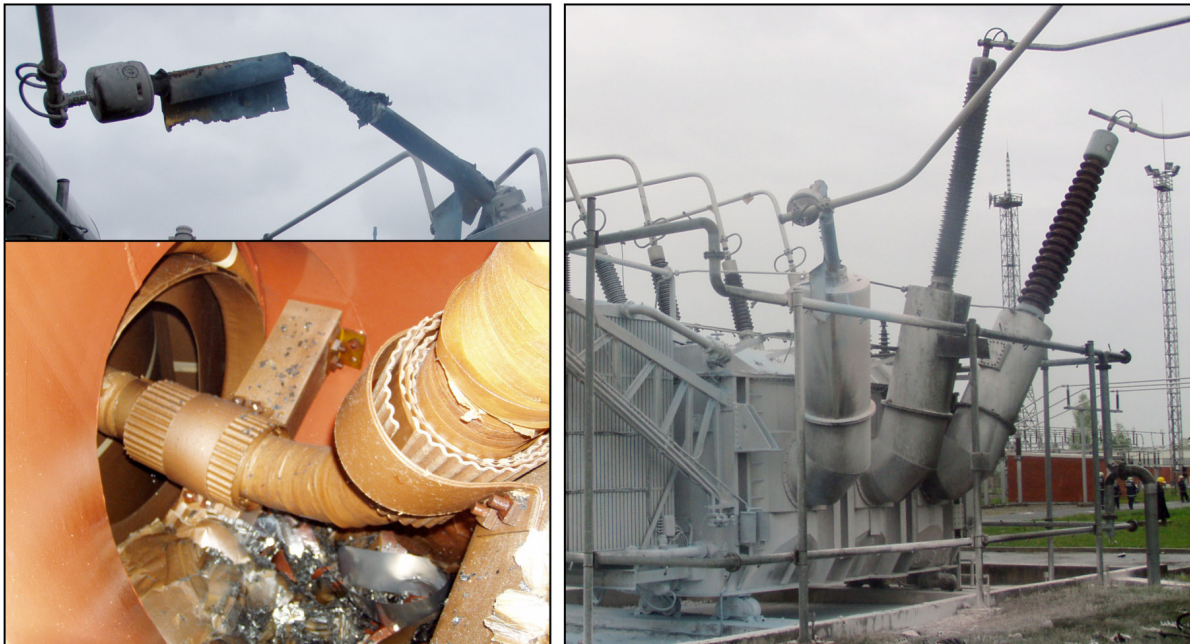
Figure 3.1: 400 kV failed bushing (up, left) and fire at 300 MVA transformer (right); bushing fragments in transformer turret and tank (down, left)

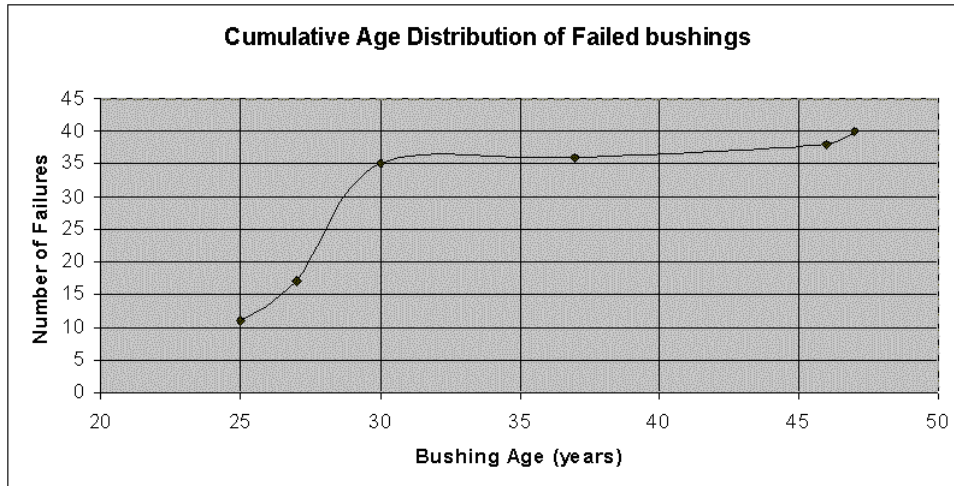
Figure 3.2.1: Australia – New Zealand cumulative age distribution of failed bushings

40 bushing failures were reported, and the average age of these failed bushings was 30 years. 6 (15 %) of the failures were terminal (catastrophic) and 34 (85 %) of the failures were incipient (bushings found to have poor test results and they were subsequently replaced). The cumulative age distribution of the failed bushings is on Figure 3.2.1, and shows a rapid increase in the range of bushings aged 25 to 30 years.

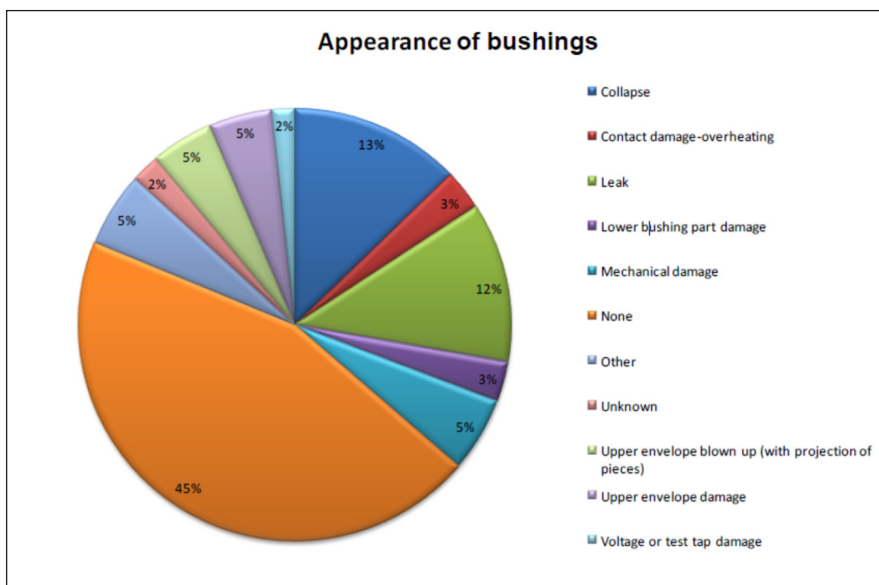
Figure 3.4.1.6: Visual appearance of all failed bushings

Based on all bushing failure data collected, visual appearance is shown in Figure 3.4.1.6.

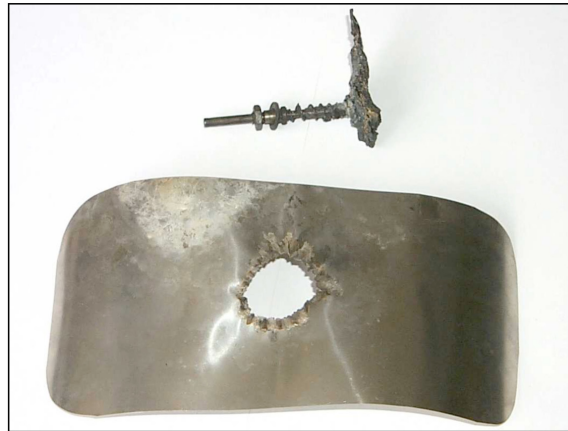
Figure 4.1.1.2: Arcing traces on last electrode and tap elements

The best prevention from this type of bushing failure is a flexible connection to the switchyard using flexible conductor (rope) or similar. Measurement of capacitance and $\tan\delta$ are good measure for diagnostic prevention.

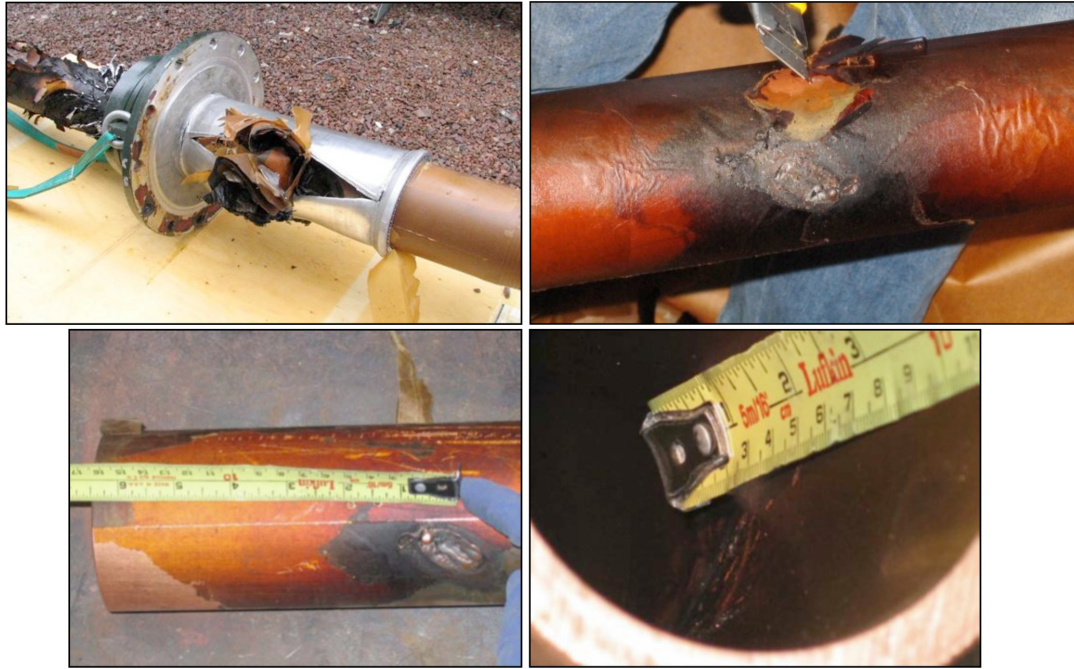
Figure 4.1.2.2: 700 kV transformer failure; top left: 300 kV failed bushing, top right: intensive thermal degradation of paper near central tube, bottom: breakdown traces on the outer side of central tube (left) corresponds to arc traces on the inner side of the tube

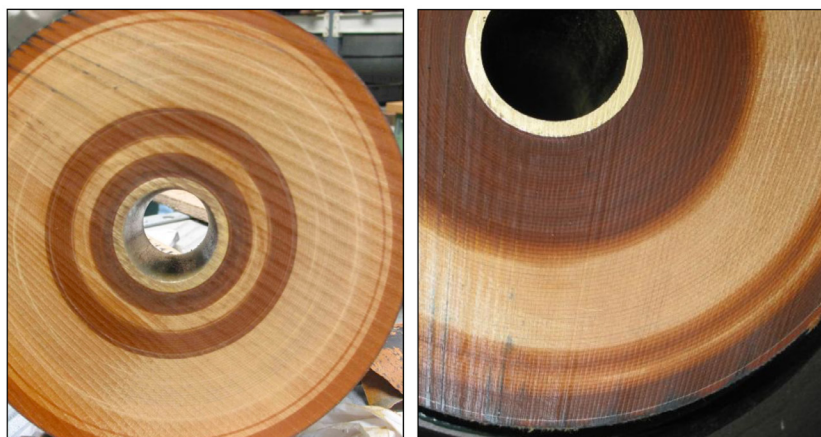
Figure 4.1.3.2: Two examples of oil penetration into RBP bushing condenser body (darker area)

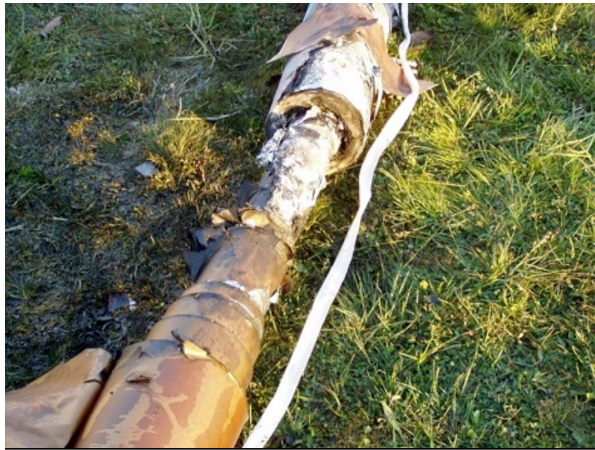
Figure 4.1.3.3: Axial destruction of OIP bushing (layer sliding) probably because of poor paper sheet overlapping

Exceptional overloading (above than according to [4.1.3.1]) can overheat paper in the vicinity of the bushing conductor up to the stage that the paper will lose its mechanical properties and reducing friction. It is assumed that such intensive ageing will affect the bushing's $\tan\delta$ and capacitance also in severe cases, and especially at elevated temperature. It should be noted again that bushing insulation does not age uniformly (e.g. paper in the vicinity of the central tube or conductor age faster than paper in the outer layers).

High voltage bushings may be very long (more than 10 m) and it is difficult to produce a sheet of paper width that corresponds to this length. Due to this, high voltage bushings are often wound with more than one paper width making up the width of the condenser. There are several ways to apply paper sheet axial "overlapping". This overlapping can be a weak point. Figure 4.1.3.3 shows the axial destruction of an OIP bushing active part after a terminal failure accompanied with fire (refer to Figure 3.1). It appears that some layers of the condenser body slid on to one another. Also, a sheet of paper overlapping is at the same axial position of the condenser body and that is probably a weak point. Examination of previous periodic diagnostic measurements [4.1.3.2] reveals that progression of this failure mode is fast. Thus, for prevention of this failure mode, a continuous on-line monitoring system seems to be much more effective than periodic measurement. It can be recognized with capacitance and $\tan\delta$ rise, and oil pressure rise just before failure. DGA will show arcing in the insulation system.

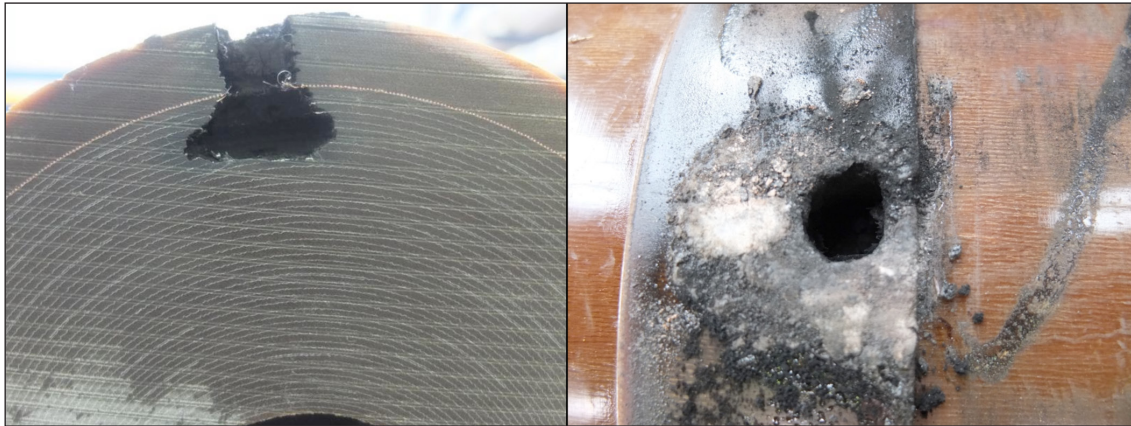
Figure 4.1.3.10: Test tap problem that penetrated deeply into the RIP body possibly caused by VFT (left core cut view, right: damaged test tap)

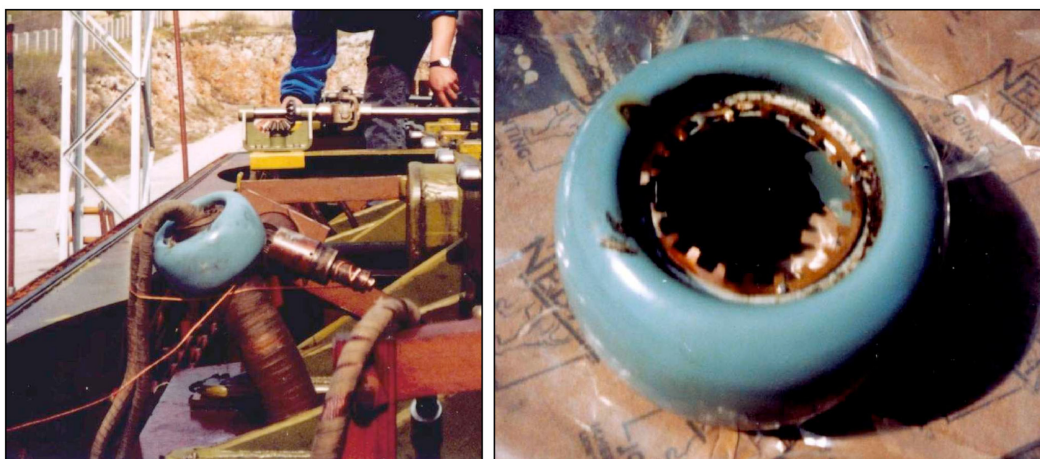
Figure 4.1.3.13: 245 kV bushing end shield fallen down (left), low energy arc traces on the shield (right)

End shield assembly problems occur because of poor fixation design, poor on-site installation or both. Under the influence of mechanical forces and vibration in service, the end shield can fall off the bushing. Normally it will stop somewhere below the bushing's lower end, hung-up on the lead. Possible consequences are intensive PD activity, low energy arcing in oil or even breakdown, Figure 4.1.3.13.

This can be detected thorough DGA analysis (PD or low energy arcing) or Buchholz relay first stage activation. Electrical off-line periodic diagnostic methods would not indicate any changes to the previous measurement with the exception of a small (often insignificant) bushing capacitance change. It can be assumed that on-site PD measurement or AE-PD location will detect the problem.

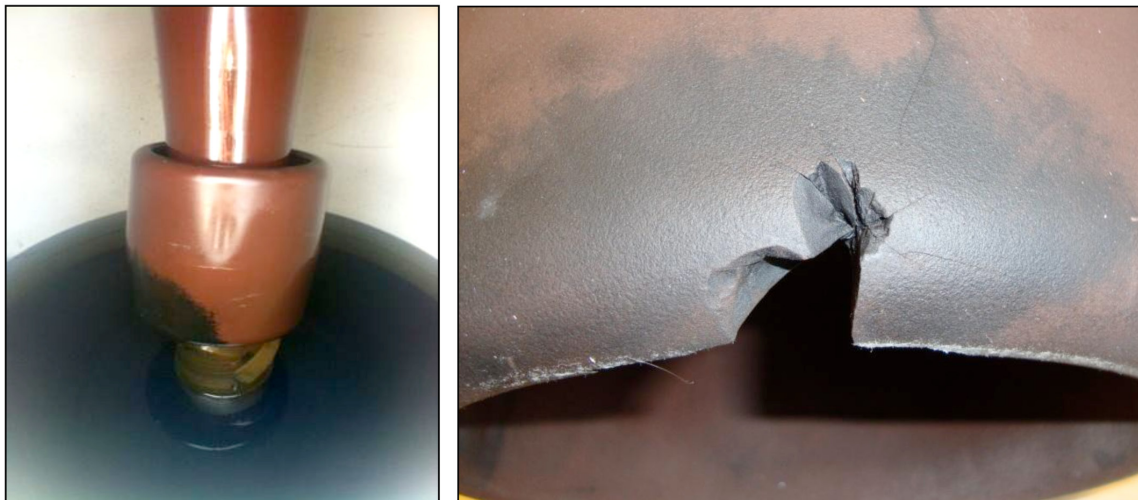
Figure 4.1.3.14: Two examples of similar cases showing end shield electrical problems: breakdown traces on 420 kV bushing end shield in turret (left), detail of end shield resin rupture after breakdown (right)

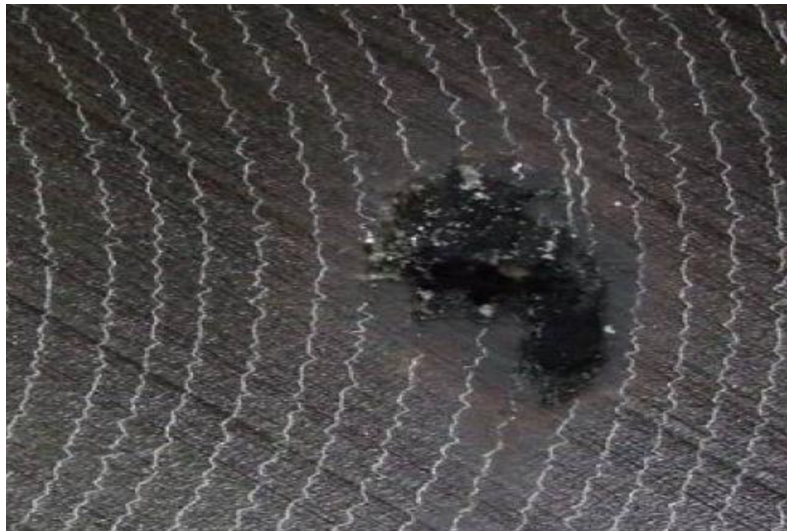
Figure 4.1.3.15: Cavity in RIP possibly caused by VFT (enlarged)

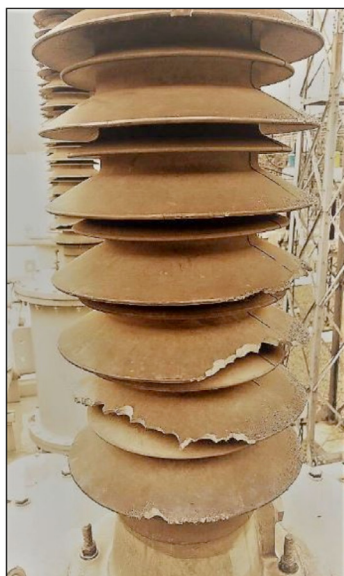
Figure 4.1.4.4: In-service bushing's silicon sheds attacked by monkeys [3.2.8]

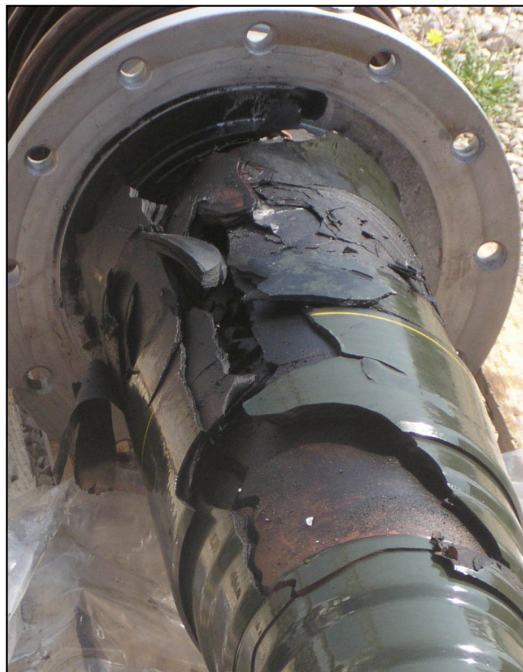
Figure 4.3.1: Exploded oil part of 30 years old, 245 kV, RBP bushing

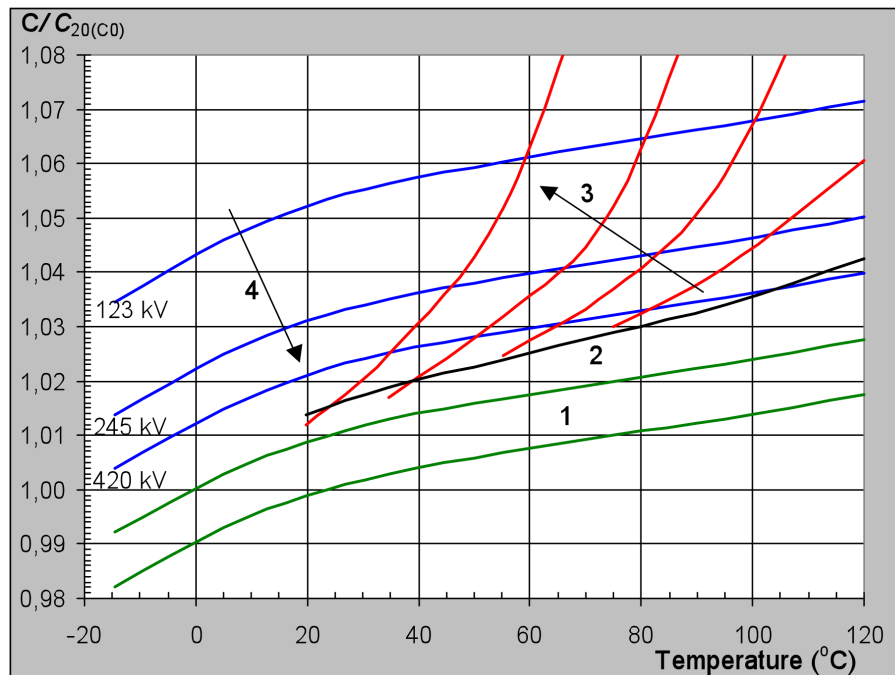
- 1 – Normal change of capacitance during the bushing’s life (area between green lines)
- 2 – Criteria for qualitative assessment of ageing and water content (black line)
- 3 – Capacitance change caused by ageing and water content (arrow direction through red lines corresponds to an increase in ageing and water content)
- 4 – Capacitance change caused by a breakdown between the condenser layers (blue lines), (arrow is in the direction of increasing bushing rated voltage)

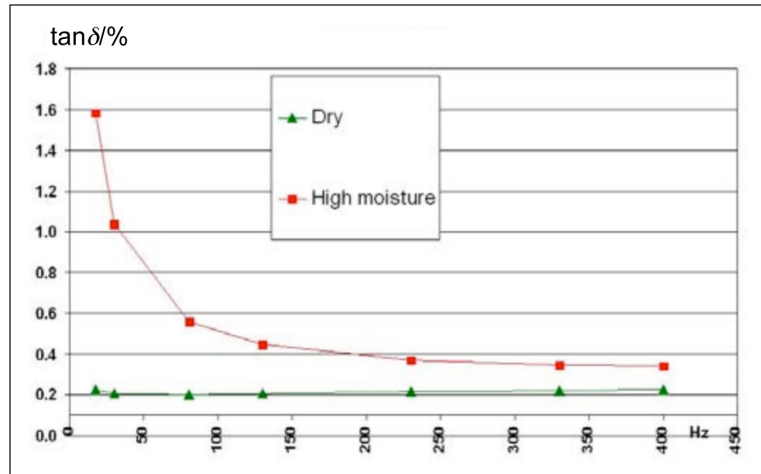
Figure 5.2.3.8: FDS measurement on a dry and wet OIP bushing over a frequency range of 15 to 400 Hz

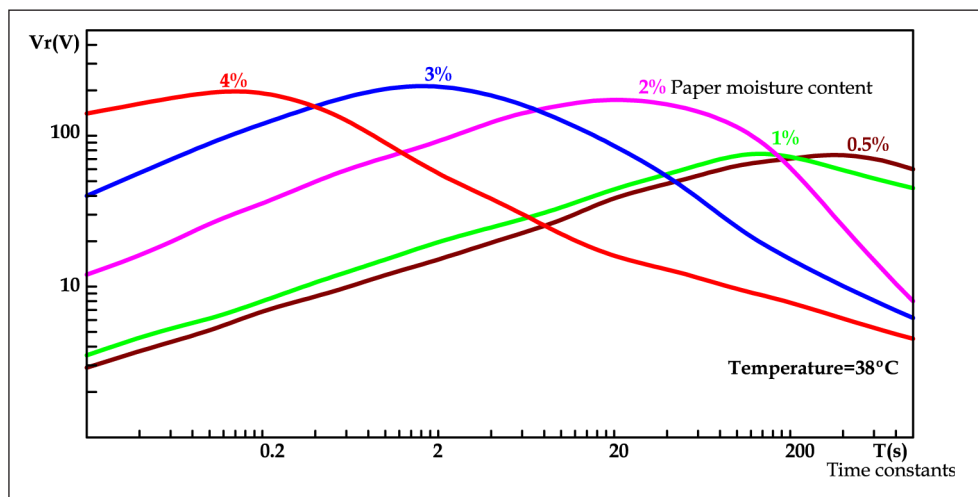
Figure 5.2.3.11: Polarization spectra for various moisture content in the paper determined by RVM method, [5.2.3.9]

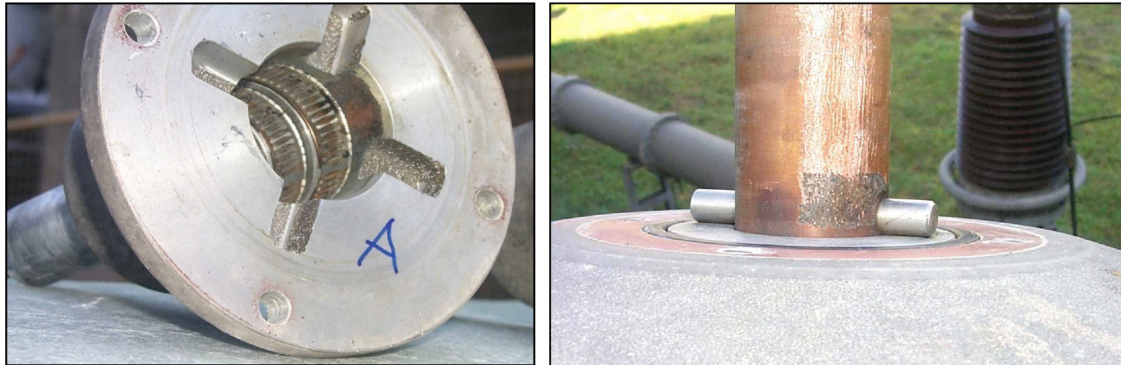
Figure 5.2.4.1: Overheating traces on a 220 kV bushing upper connection (left: on the multi-contacts and upper aluminium connection, right: on copper bolt above bushing head)

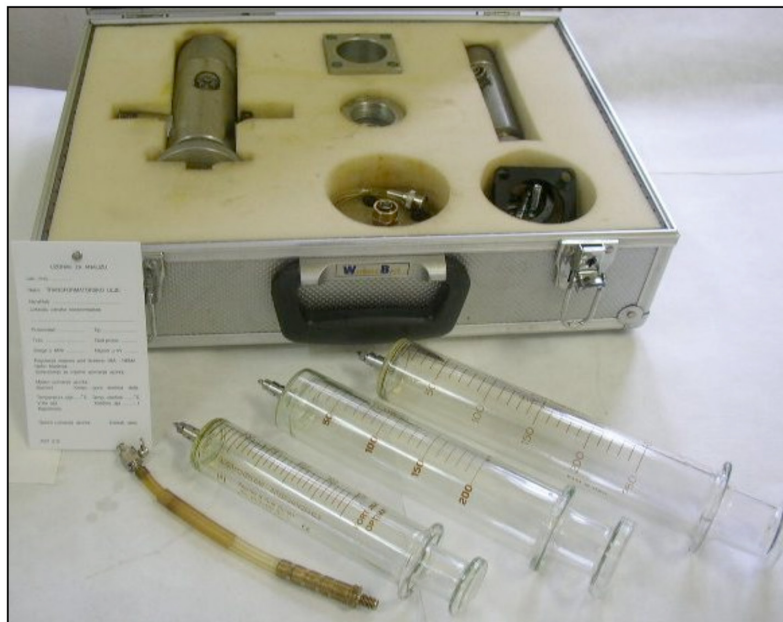
Figure 5.3.1.1: Oil sampling kit, an example

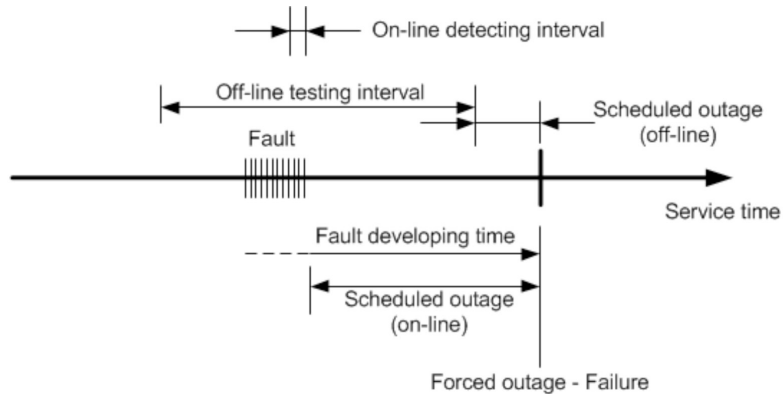
Figure 5.5.1. Bushing off-line and on-line initial failure (fault) time recognition and related scheduled outage

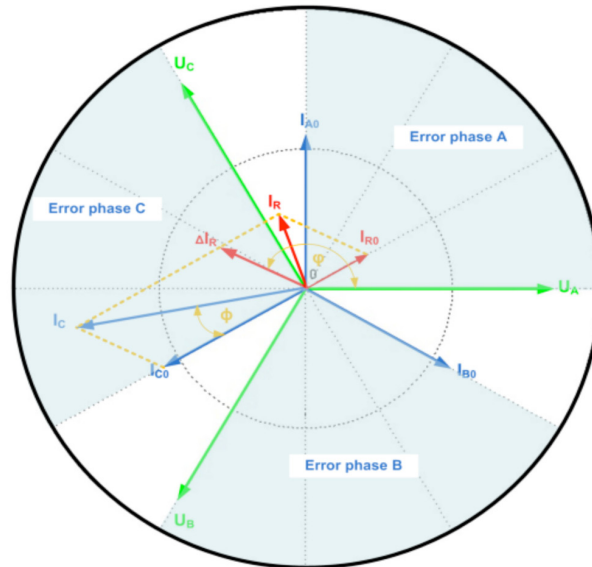
Figure 5.5.2.2: Sum of phasor bushing monitoring method basics (current phasors are not to scale)

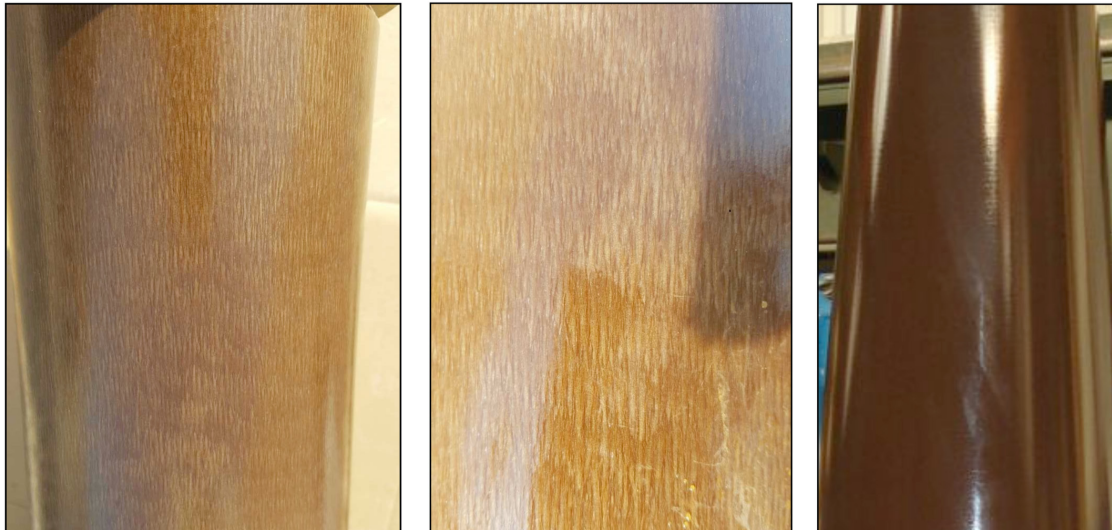
Figure 6.1: RIP bushing's oil part visual appearance; left: humidified body, centre: humidified body – enlarged, right: dry

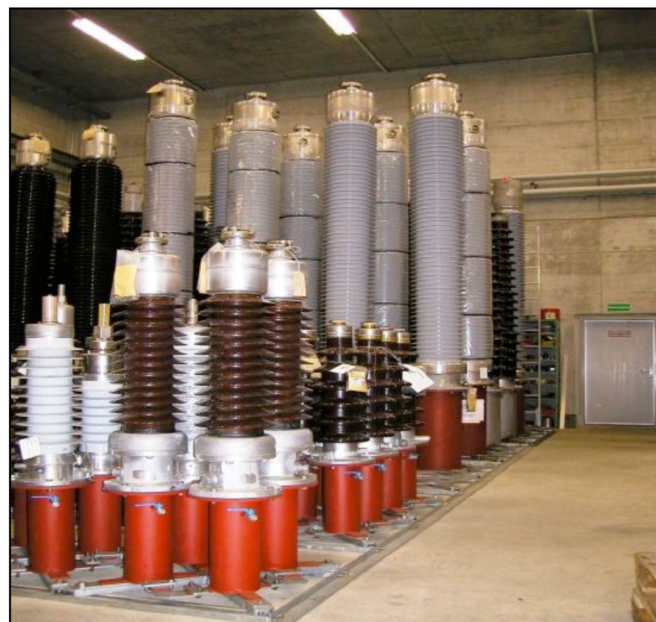
Figure 6.3: Example of long-term storage of various bushing types, [3.2.8]

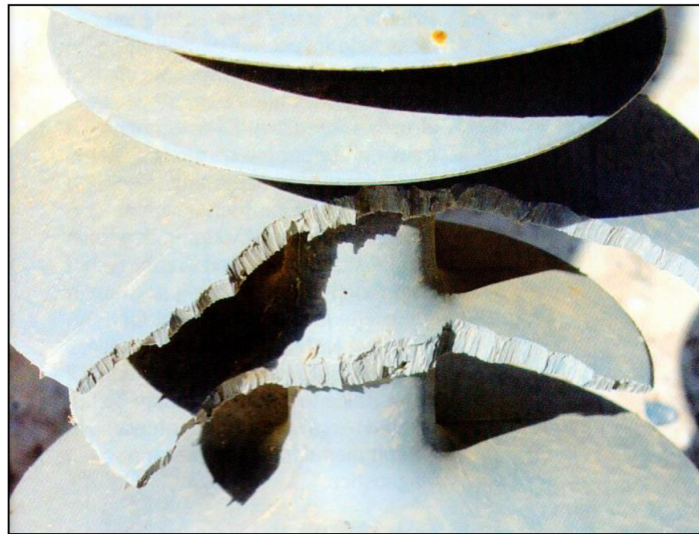
Figure 6.4: Example of rodent attack on the silicone sheds [6.1]

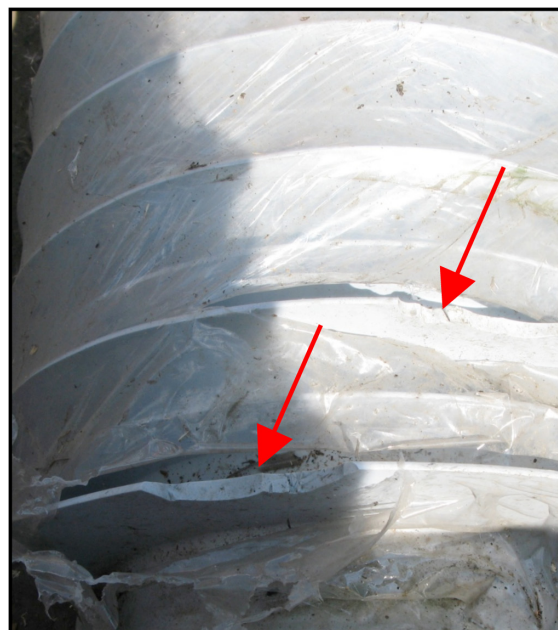
Figure 6.5: Example of rodent attack on the silicone sheds after 10 years storage in the original package (marked with red arrows)
